Docket No. 217 – Development and Management Plan Inspection

Northeast Utilities Service Company Certificate of Environmental Compatibility and Public Need for the construction of a 345-kV electric transmission line and reconstruction of an existing 115-kV electric transmission line between Connecticut Light and Power Company's Plumtree Substation in Bethel, through the towns of Redding, Weston, and Wilton, and to the Norwalk Substation in Norwalk, Connecticut.

Date: May 17, 2005

Location: 345kV XLPE Component

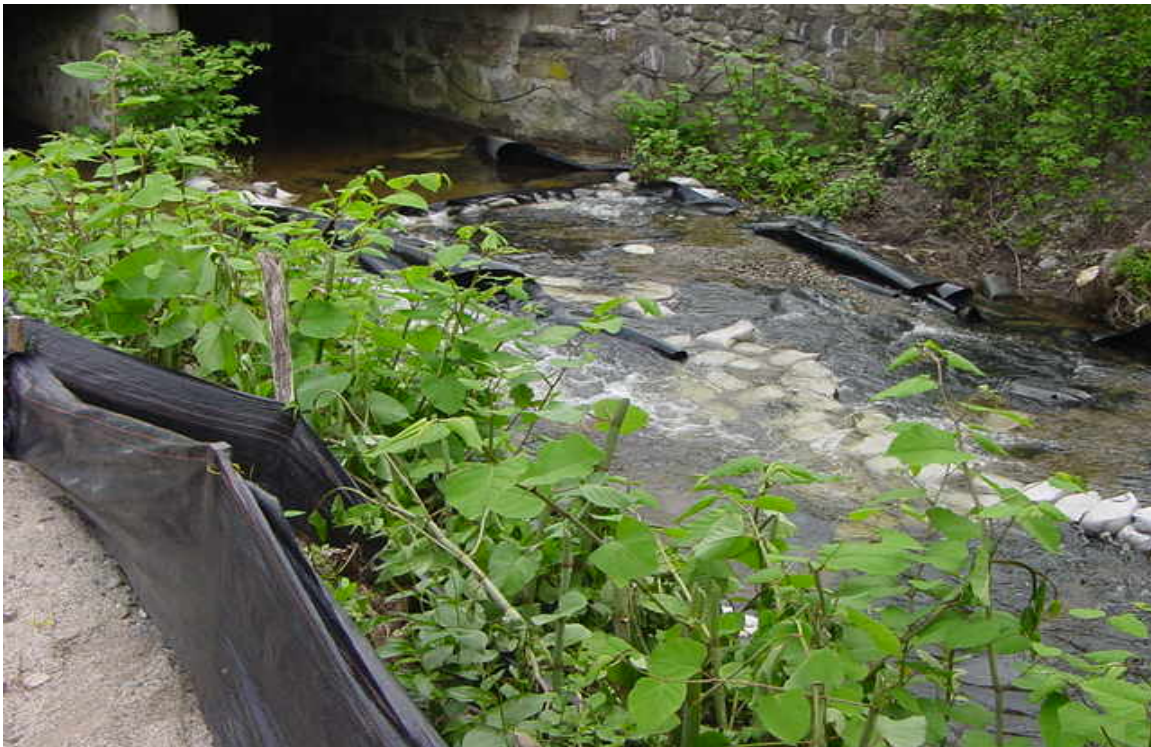
-The plastic liner remains within the stream bed. The sandbag	-The stream was still running clear at the time and diversions will be	-N/A at the time

Inland Wetland and Watercourse encroachment and mitigation	<p>-East Swamp Brook crosses under Plumtrees Rd. A large plastic liner is in place across the bed and up along the banks to keep water out of the bore trench. The sandbag diversion is also in place. 5/17/06</p> <p>-Problems with excess water continue in the trench and further methods are being evaluated. 5/4-5/17/06.</p>	<p>- The stream continues to run clear. The liner and diversions will be removed soon. 5/17/06</p> <p>Watch the banks where soil was disturbed for any erosion. 2/16-5/17/06</p> <p>- Sheet piling in the stream may be necessary and appropriate permits will be obtained. Options are still being evaluated 5/4-5/17/06</p>	<p>-N/A at this time until the work is complete</p> <p>- N/A at this time.</p>
State species of concern, threatened and endangered species	<p>-The D&M plan and clearance letter states that state-listed species are not located in this work area.</p> <p>-However, a wood turtle was noted at Plumtree Substation last spring. 5/17/06</p>	<p>- N/A</p> <p>-345kV XLPE crews should also be performing daily walkthroughs before moving equipment in the morning if work returns here. 4/26-5/17/06</p>	-N/A

345kV XLPE: Photo shows the jack and bore stream with sandbag diversions in place. These controls will be removed soon as further options are evaluated. 5/17/06

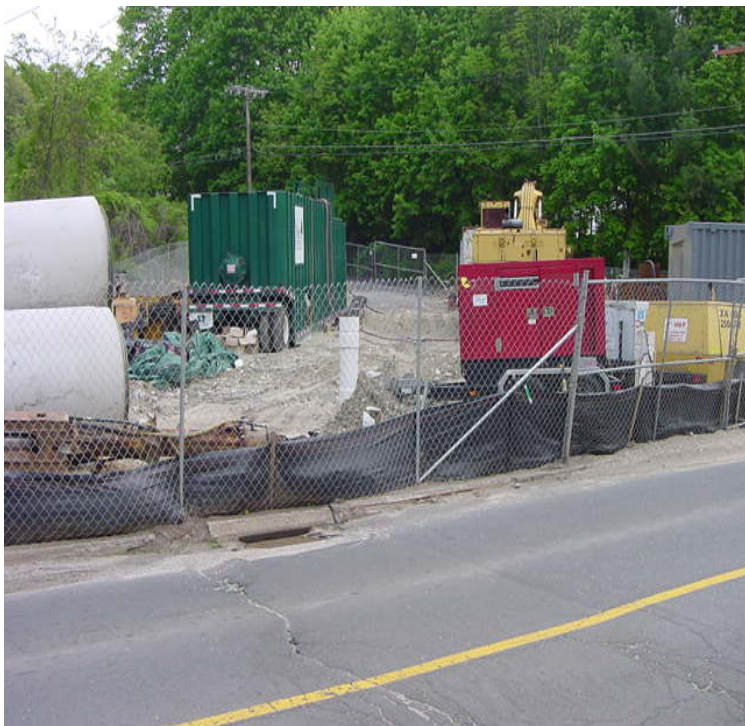
Photo on the left shows the jacking pit where no active work was occurring. Photo on the right shows the end of the work at Hoyts Hill. 5/17/06
